## EXPERTISE REPORT

December 2013

# Sazani island (Albania) : pollution and wastes field survey

Jean-Louis Lambeaux (13 Développement)

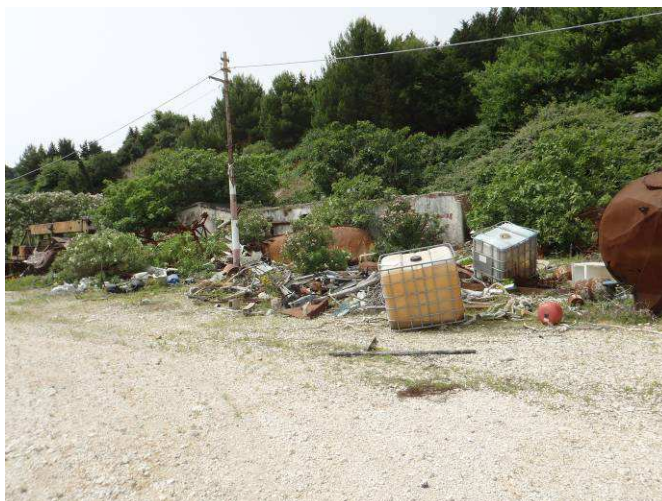
### Location 1 :

Close to the harbour, this place is a wasteland area. Soils are littered of pieces of metal as : a big tank (about 100 m3), a crane, a truck wreck,....

We estimate at 3 tons of easy metal to remove (except big tank), and about 1 ton of non-hazardous industrial waste (plastic, wood,...).

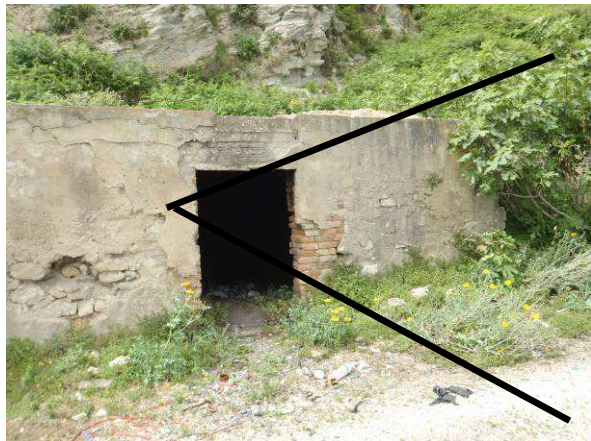
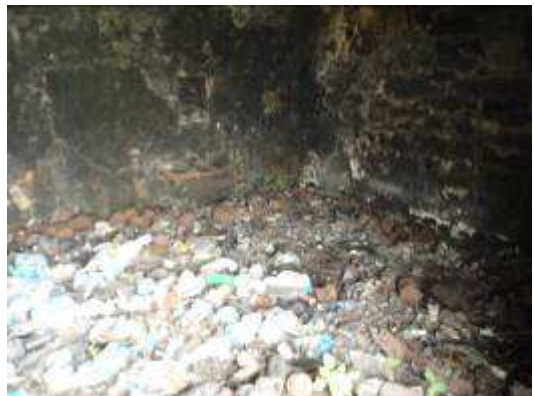
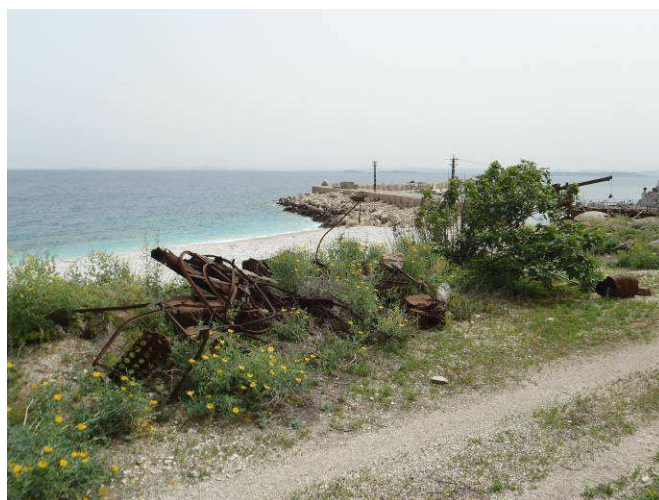
### Location 2 :

A brick-built construction which is used nowadays to burn waste. Around this place, pieces of metal: about 3.5 tons  
Plastics litters: 0.1 ton

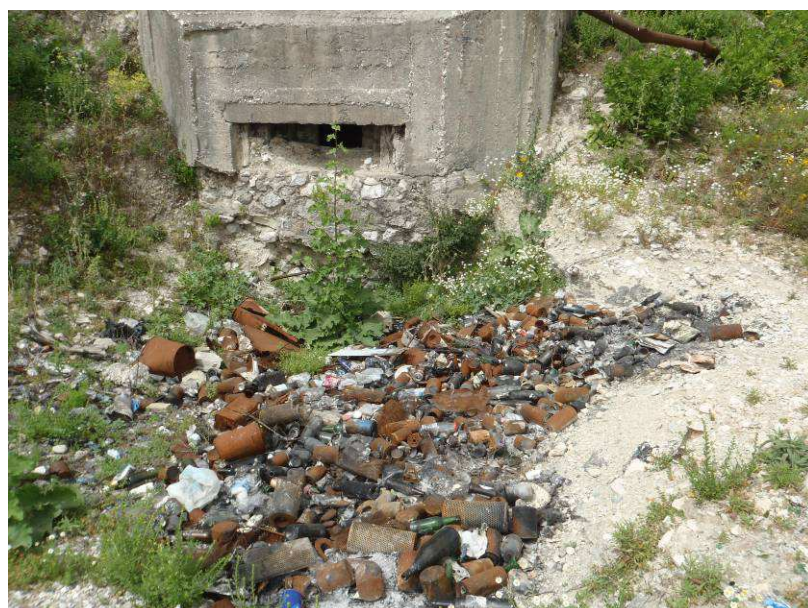
### Location 3 :

In front of a bunker, another burning site, with about 0.1 tons of metal and glass.

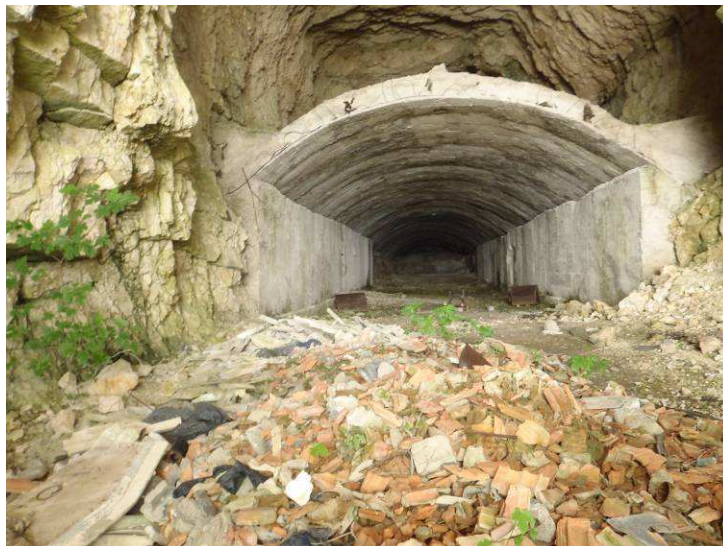
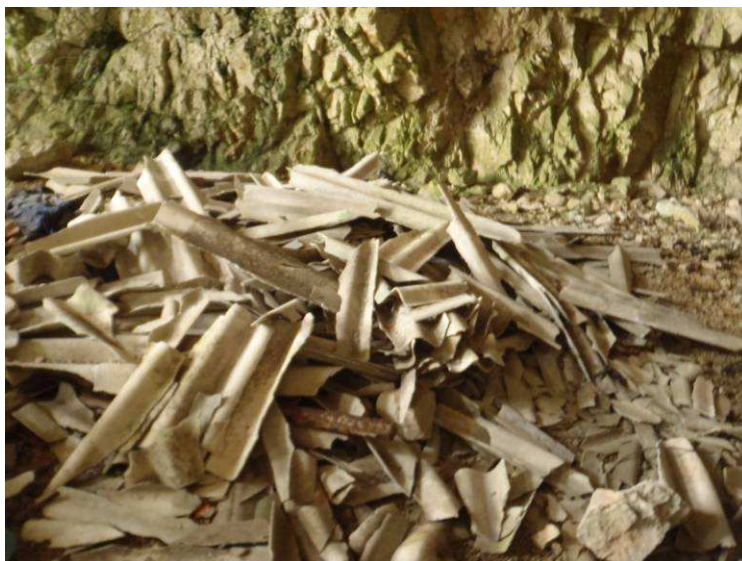
#### Location 4 :

3 large natural limestone caves reinforced with concrete vault (about 100 m long, 15 m large, 8 m height). The vault of the first one (coming from the south), is partly collapsed and dangerous.

In the middle-one, about 50 m<sup>2</sup> of demolition waste, and 10 m<sup>2</sup> of asbestos plate (vault is in good condition).

The third one is half bathed.

In front of and close to the bunkers, there are pieces of metal and 3 tanks, frame (4 tons).

One management possibility should be the containment of non-dangerous waste containment (wood, rubble...) inside a bunker in a good structural state (East zone - location 4), with reversibility possibility. Some works on the access pathway should be necessary.

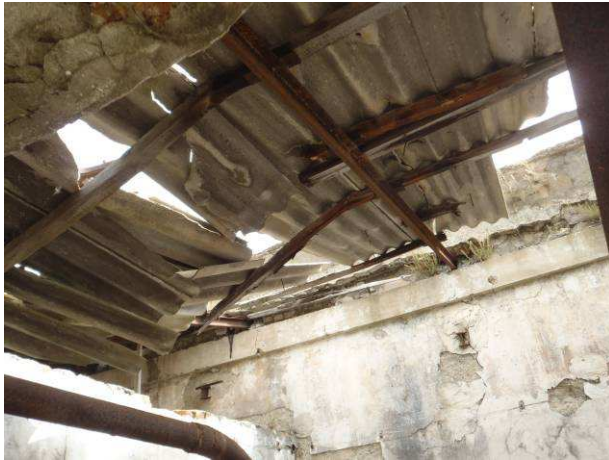
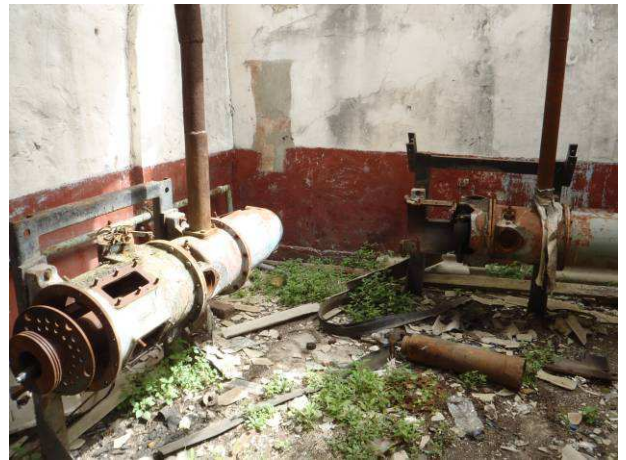
**Location 1:**

Small single floor building with a damaged roof (10 m2 of asbestos plate) and walls made of masonry.

Metal: 3 tons

Wood: 0.5ton

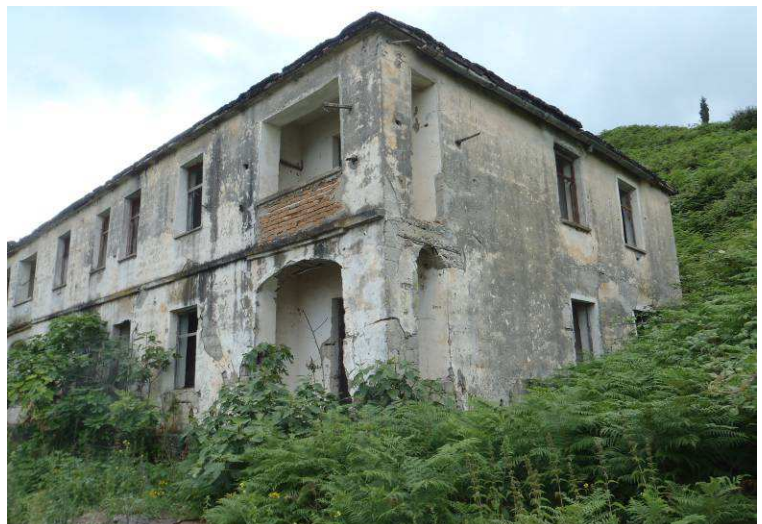
**Location 6:**

Large two-floors masonry and bricks construction with concrete flat roof.

Average condition.

Metal : 1 ton

Garbage (Wood, plastic,...) : 0.2 tons

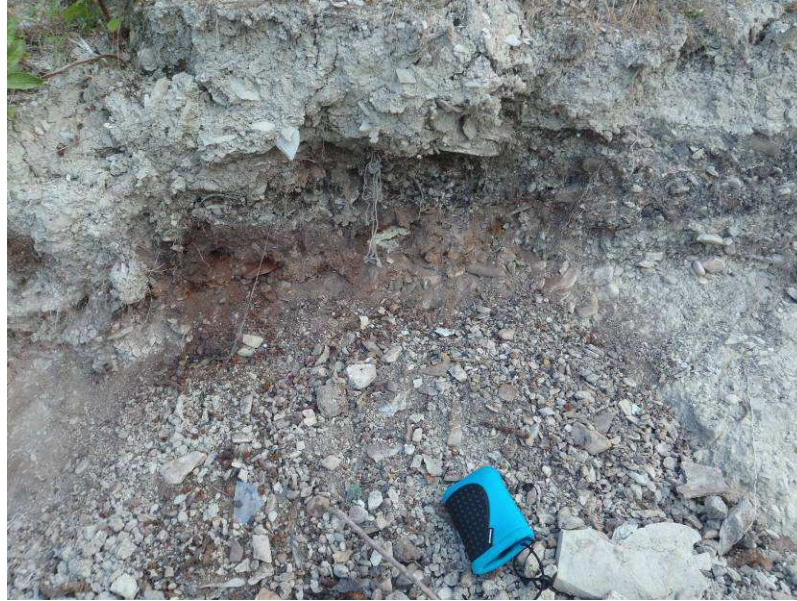
#### Location 7:

At the top of the small beach in the south of the quay. A thin soil polluted layer (0.2 m thick and about 15 m<sup>2</sup>), result of backfilling with burning wastes.

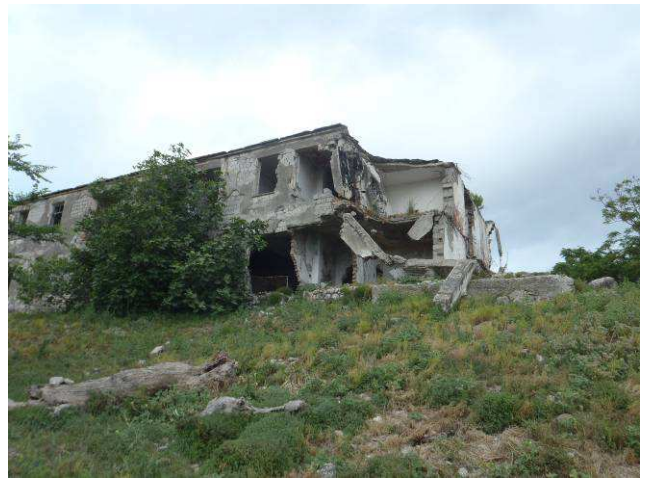
#### Location 2:

Housing : Two-floors masonry construction partly collapsed.

Metal : 1.5 tons

Garbage (wood, fabrics, mattress, plastic,...) : 0.2 tons

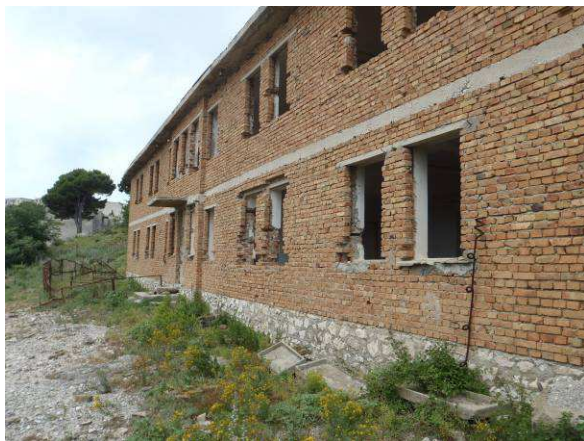
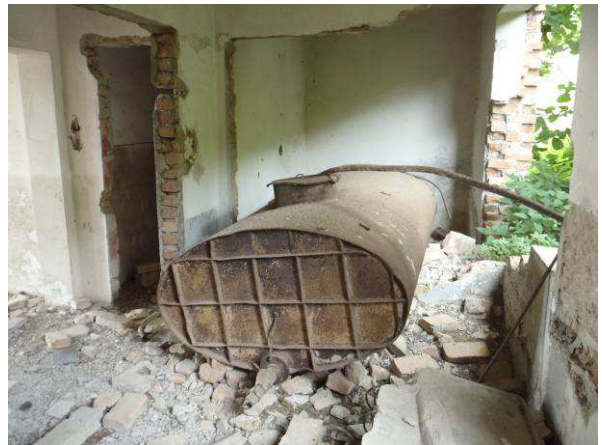
#### Location 3:

Housing : Two-floors masonry construction in average general condition (locally bad).

Metal : 1 tons

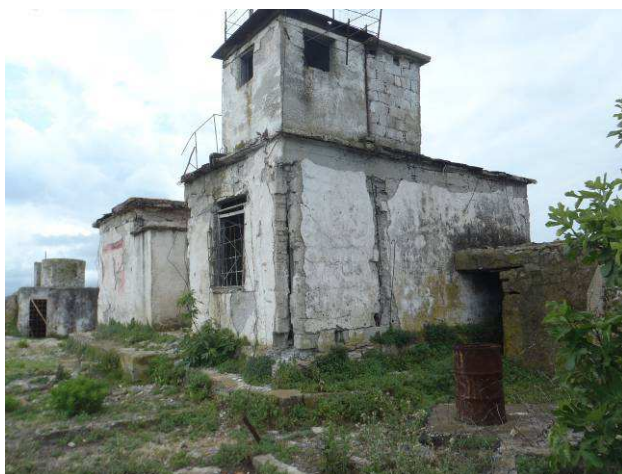
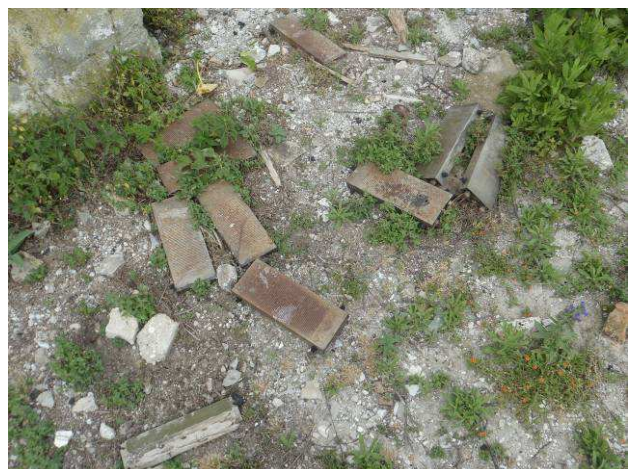
#### Location 4:

Small semaphore : Concrete and masonry construction in bad condition.

Metal : 0,3 tons (empty barrels)

Battery : 10 units

Garbage : 0.1 ton

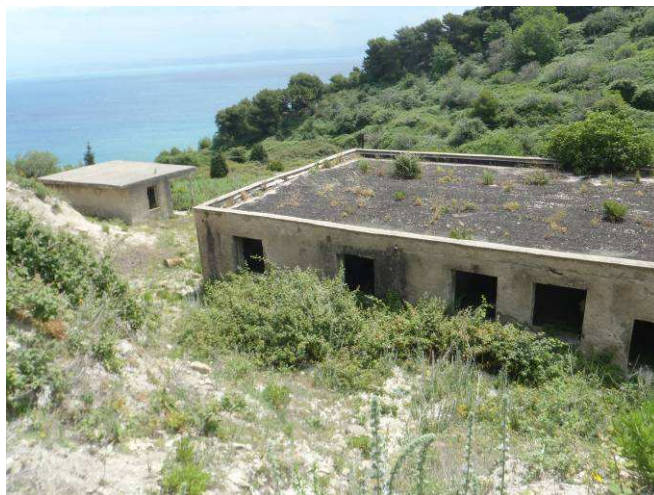
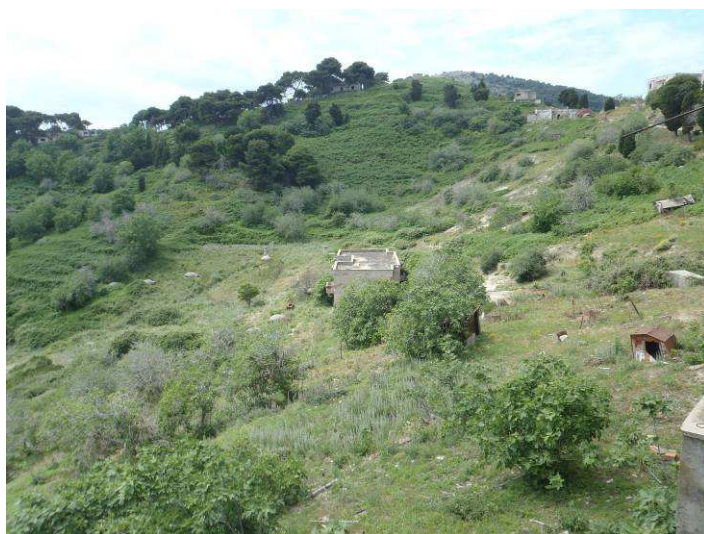
**Location 5:**  
Concrete and masonry ground floor construction in average condition.  
Metal : 0,1 tons

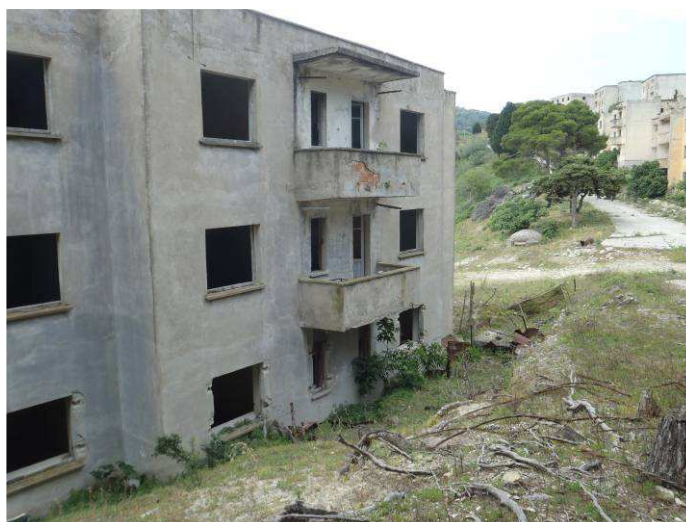
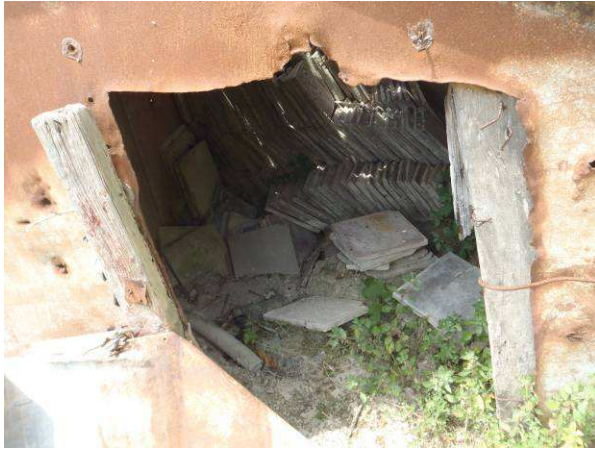
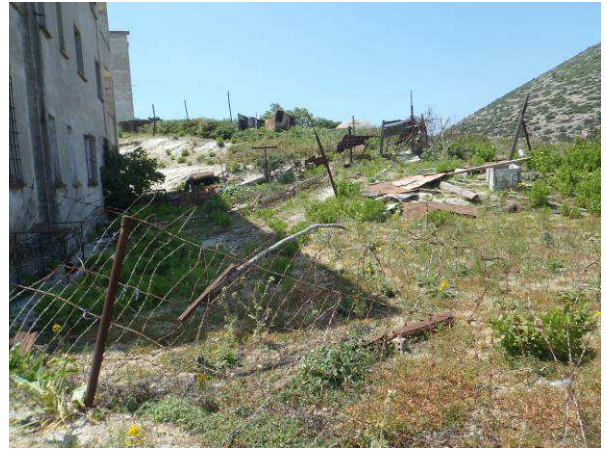
**Location 7 to 12:**

Housing : three-floors brick construction in average condition.  
Metal : 6.5 tons  
Small stock of cement stone floor  
Garbage : 1 ton

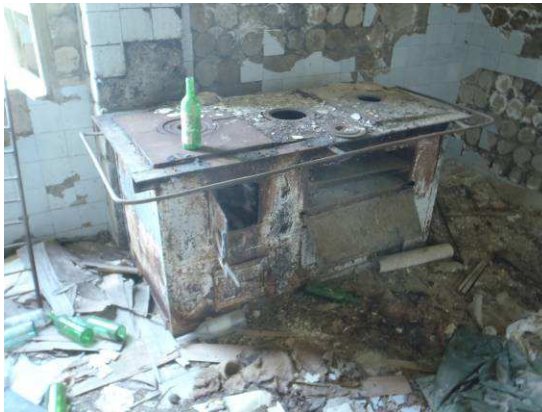
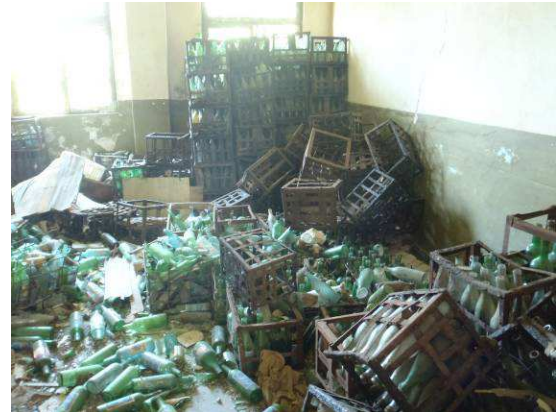
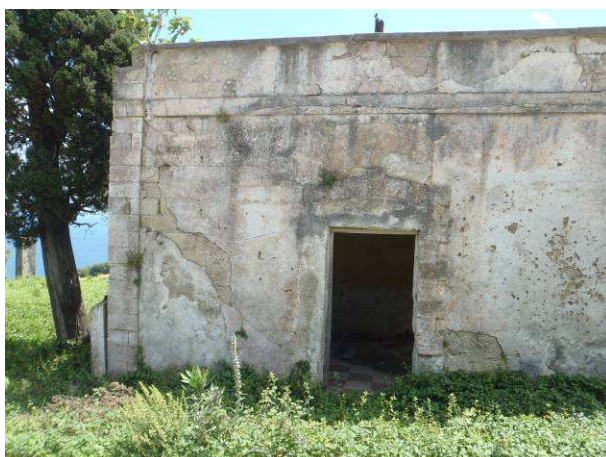
#### Location 13:

Dancing room: Masonry construction in average condition.

Metal : 1 ton

Garbage : 0.2 ton

Glass : 0.5 ton

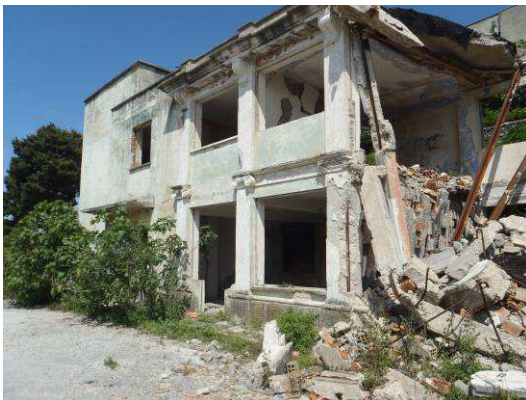
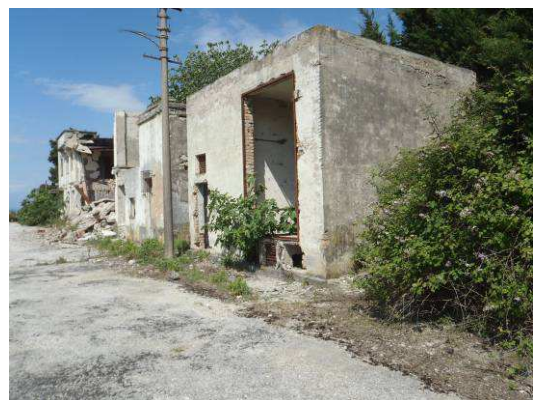
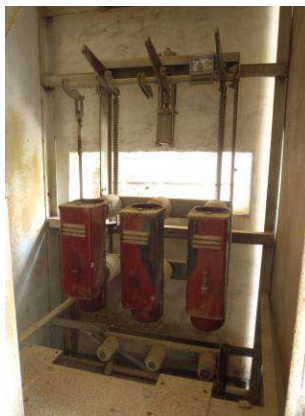
#### Location 17:

Two floors bricks and masonry construction in middling condition and partly collapsed, and small electric transformer station (electric cupboard without pyralene oil).

Metal : 0.6 tons

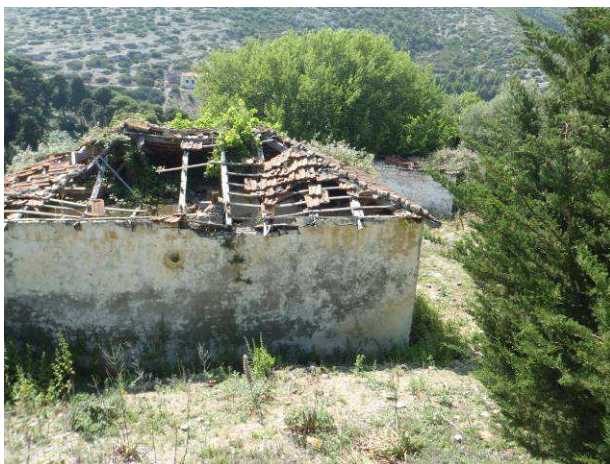
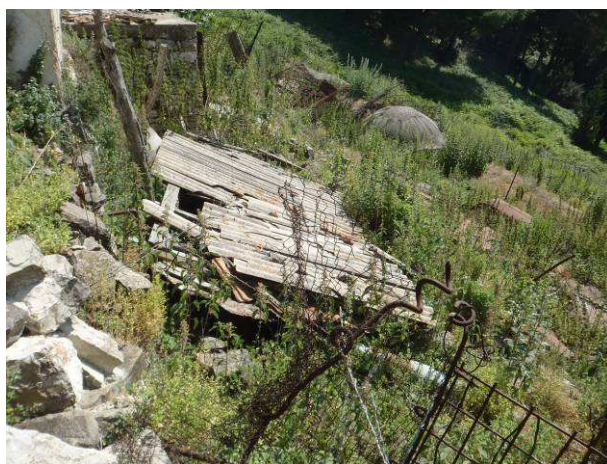
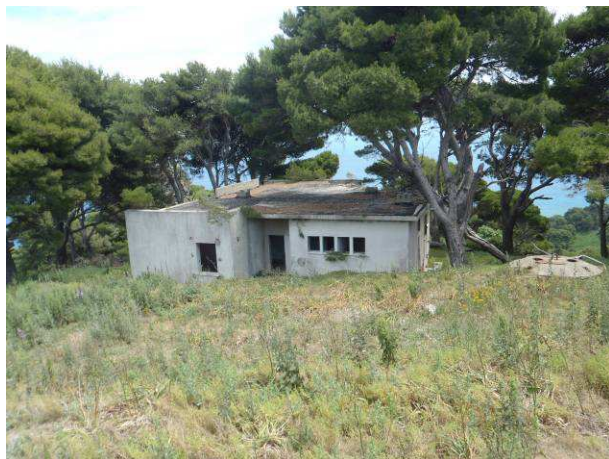
**Location 18:**

Eight small traditional houses in middling condition (3 of them in ruin) and locally bad (roof partly collapsed and).  
Metal : 0.6 tons  
20 m2 of plate in asbestos.

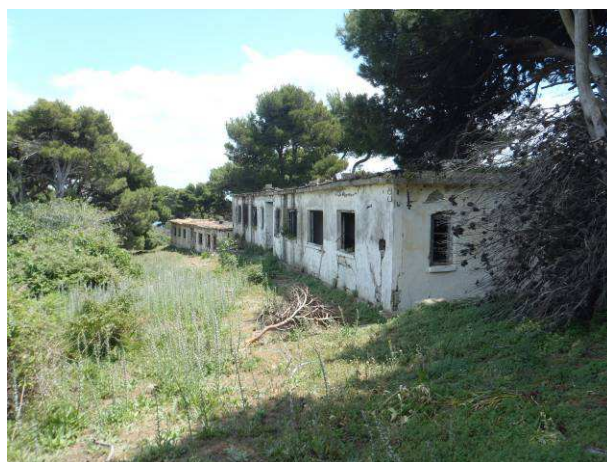
**Location 20:**

Group of four small ground-floor masonry constructions in middling condition and locally bad.  
Metal : 1 ton  
Garbage (wood) : 0.5 ton

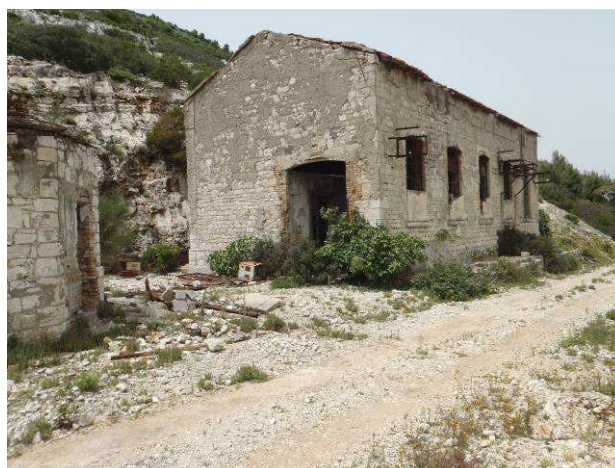
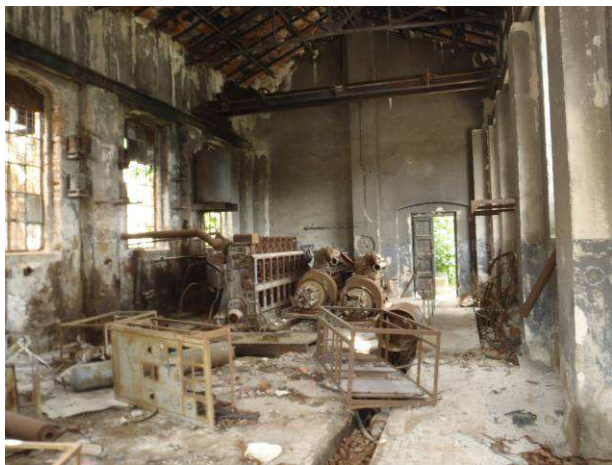
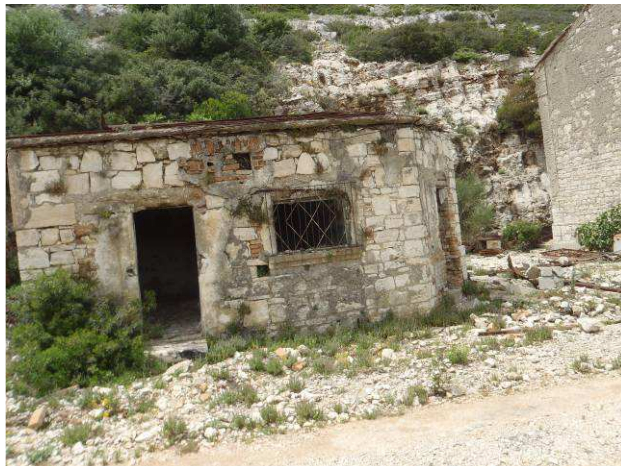
### Location 1:

Two limestone blocks constructions in good condition (unsteady concrete roof on the small construction). 3 generators sets and 2 metallic tanks. A bunker with 2 generators sets.

Metal : 3.5 tons (not counting generators to leave).  
Garbage (wood) : 0.5 ton

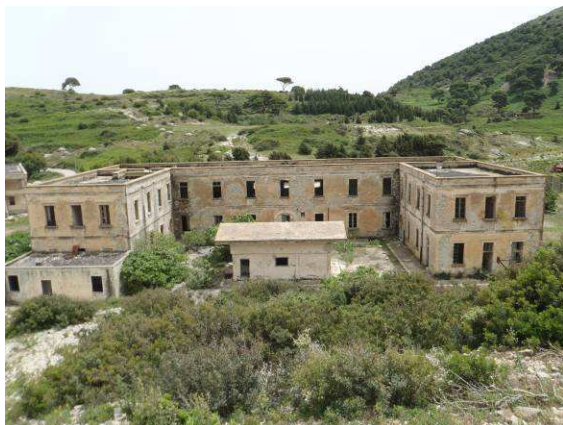
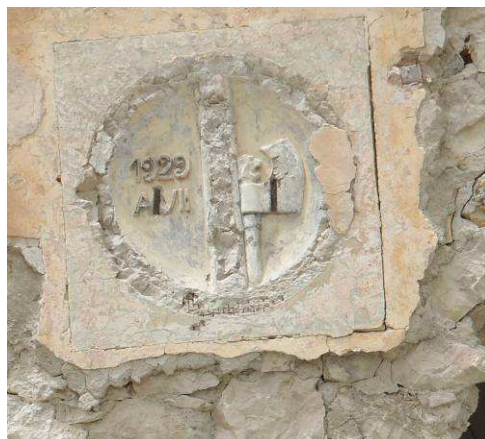
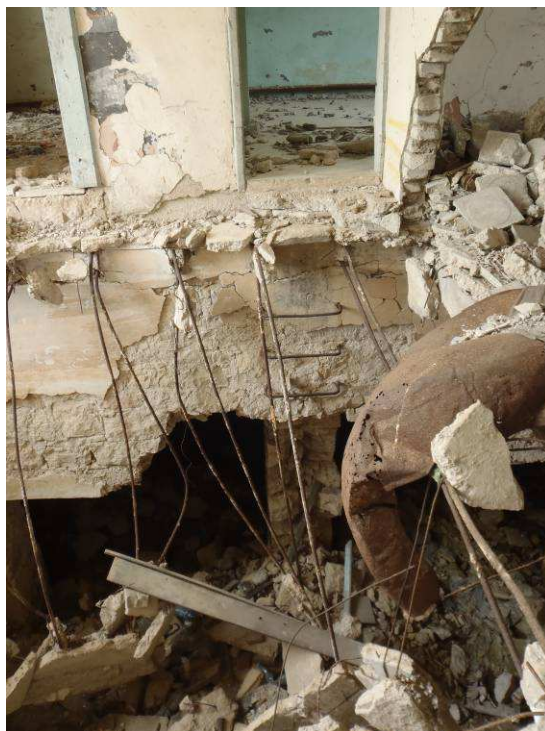
## Location 2:

Hospital (1929). Two grounds limestone blocks constructions in quite good condition - basement inaccessible (locally collapsed parts). Concrete roof must be inspected in detail.

Metal : 3 tons (counting boiler).

Battery : 30 units

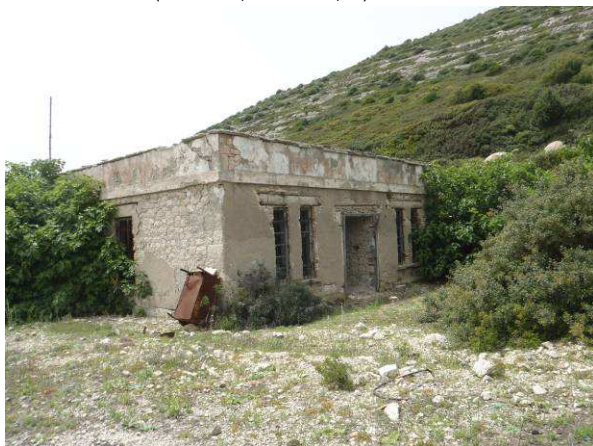
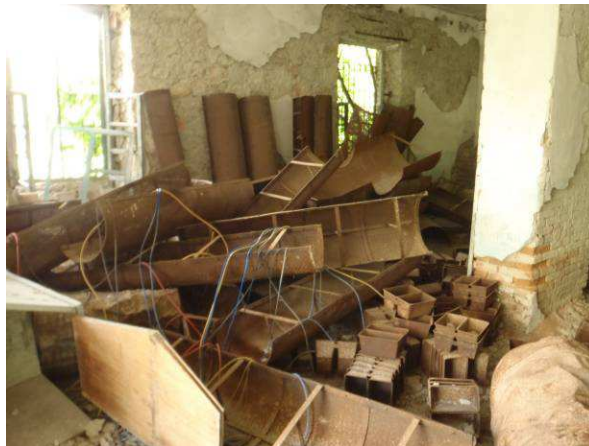
**Location 3:**

Bakery?. Ground floor limestone construction in middling condition.

Metal : 3.5 tons (screen?, crusher,...).

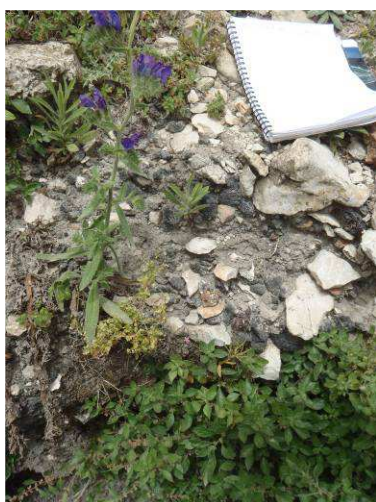
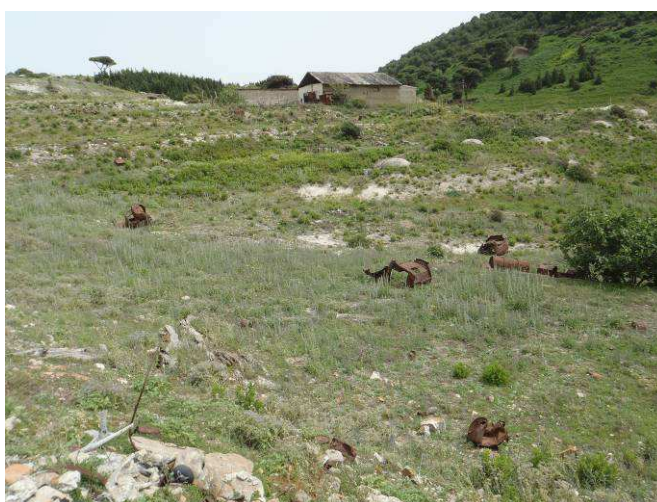
**Location 6:**

Ground floor bricks construction.

Metal : 0.4 ton (5 empty barrels, 8 beam balances)

Boxes with glass bottles: 0.3 ton

Near and in the south-est of this construction, a thin soil polluted layer, result of backfilling with burning wastes (0.3 m thick, area extension area undefined).

10 metallic elements (tanks, part of a truck,...). : 3 tons

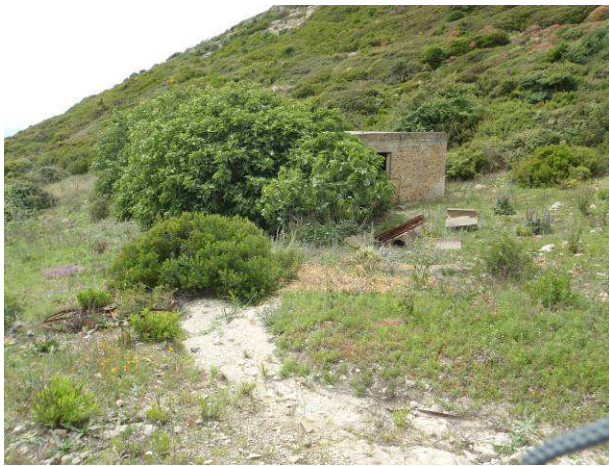
**Location 7:**  
Only foundations remains.  
Metal : few military helmets

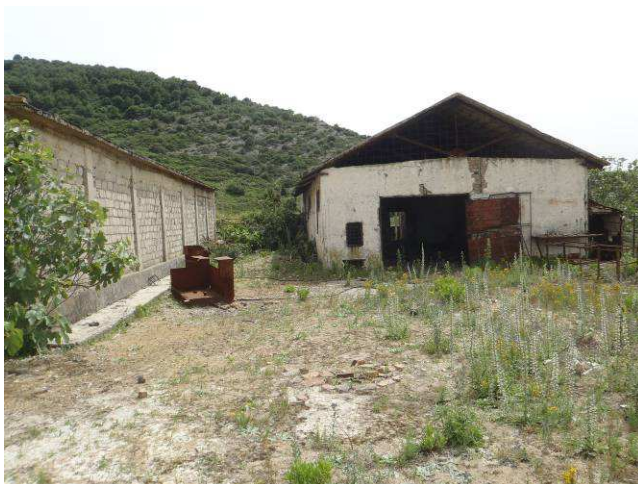
**Location 9:**  
Ground floor collapsed masonry construction.  
Metal : 0.5 ton (car wreck)

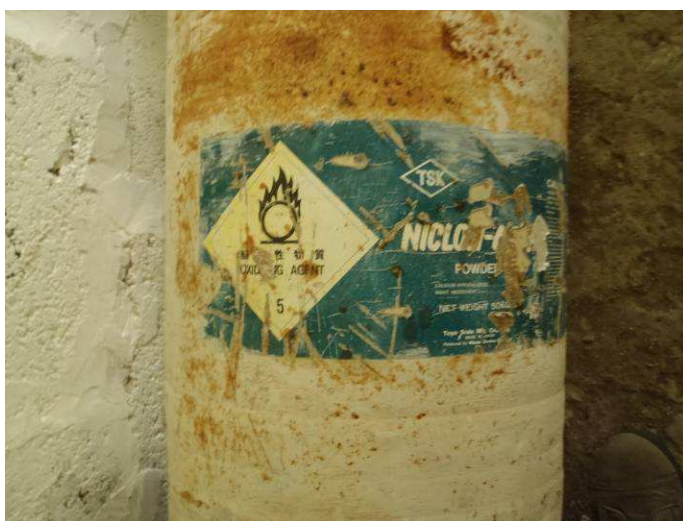
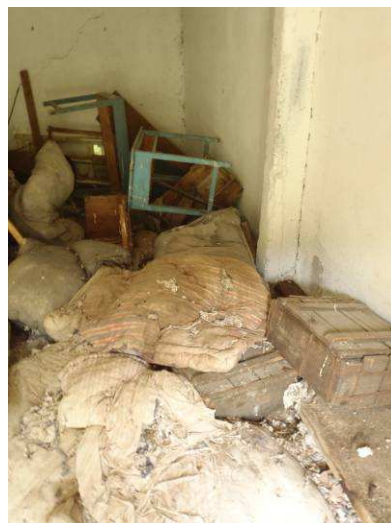
**Location 13:**

Ground floor bricks construction.

Metal : 0.5 tons

Non-hazardous industrial waste : 0.2 ton (wood, mattress,...)

3 barrel of hazardous wastes (calcium hypochlorite : Oxidant (O)Corrosive (C)Harmful (Xn)Dangerous for the environment (N) - R-phrases :R8, R22, R31, R34, R50)

5 barrels full of undefined substances.

Dangerous wastes (batteries, asbestos, powder filled barrels ...) must be evacuated on the continent by a specialized company (with specific individual equipment).

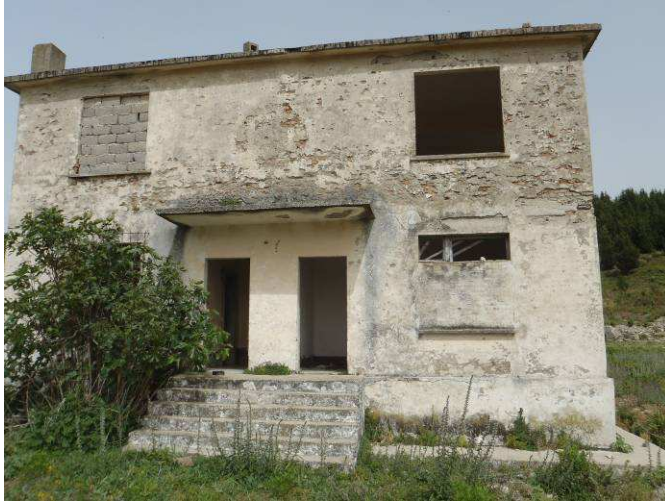
**Location 17:**

Ground floor masonry construction. Roof in asbestos plates collapsed (30 m<sup>2</sup>).

Metal : 0.1 ton (empty barrels)

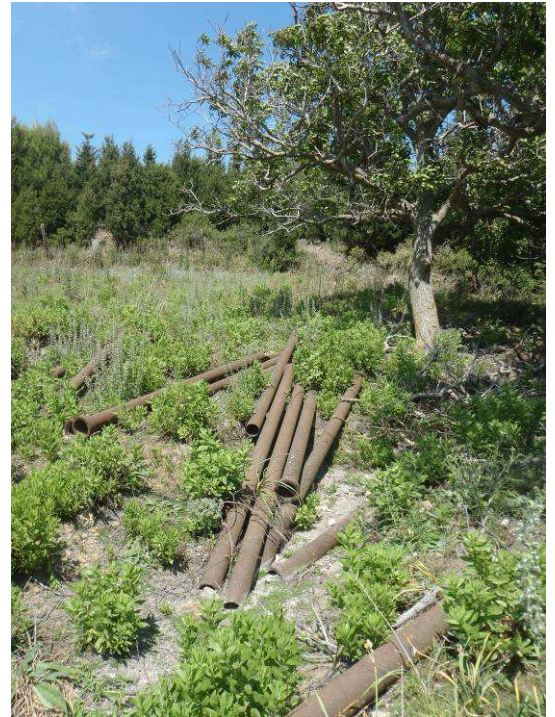
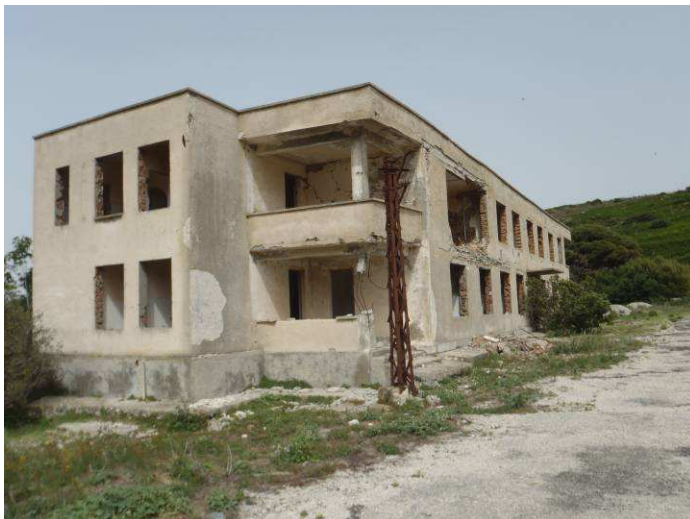
**Location 19:**

Metal : About 30 metallic pipes (5 m long) : 4 tons

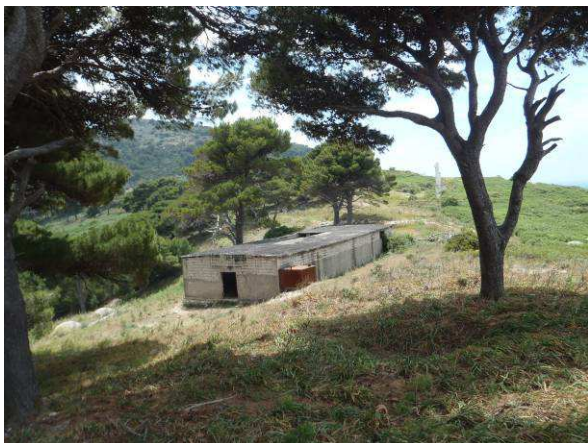
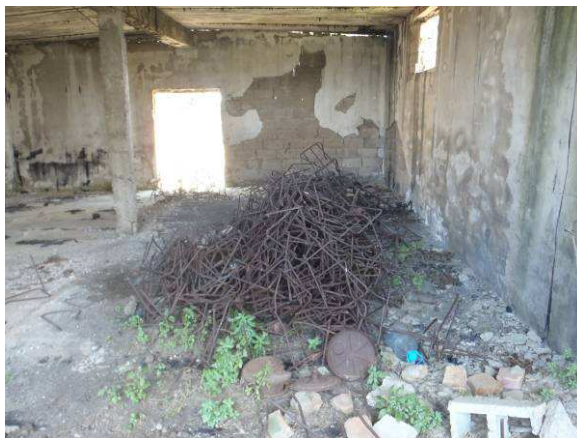
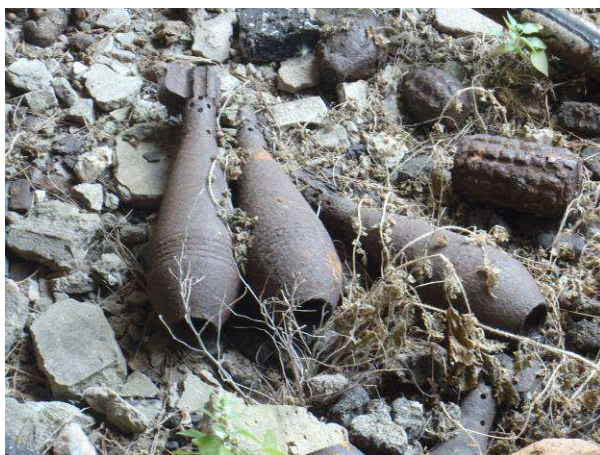
**Location 21:**  
Ground floor impair masonry construction.  
Metal : 0.3 ton

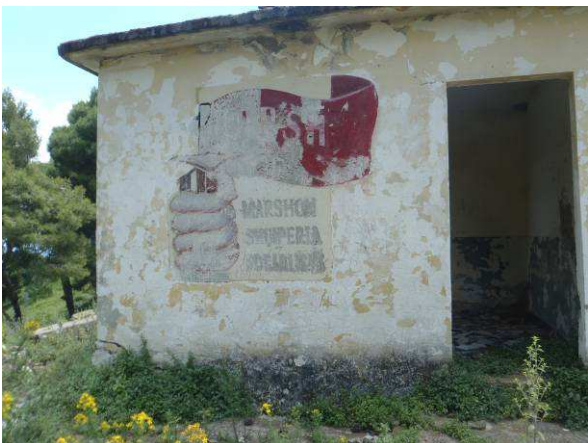
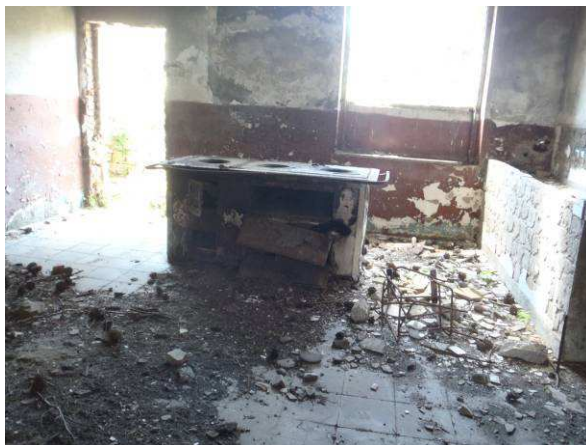
**Location 22:**  
Ground floor bricks construction in middling condition.  
Metal : 0.2 tons

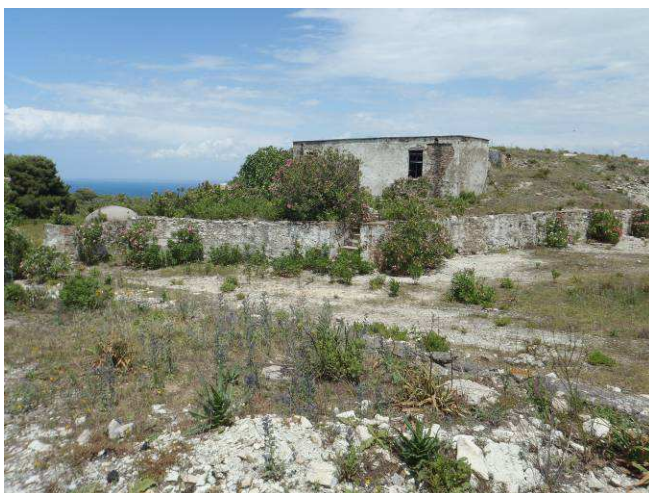
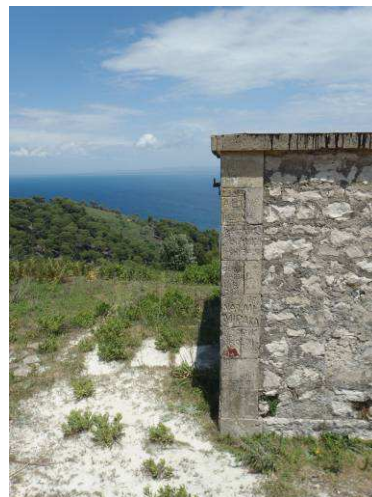
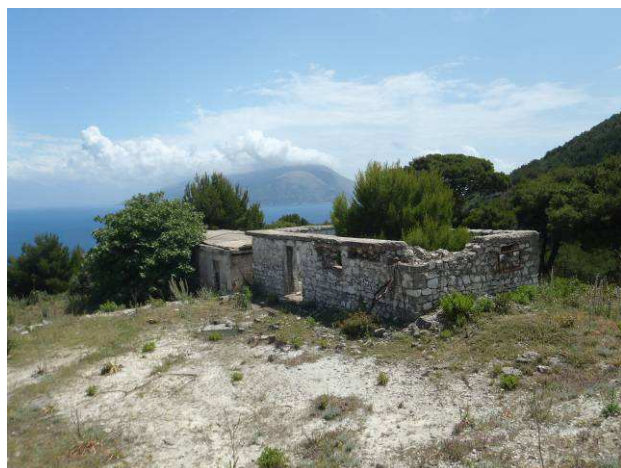
**Location 23:**

Two small ground floor bricks and limestone blocks constructions in quite good condition.

Metal : 0.1 ton

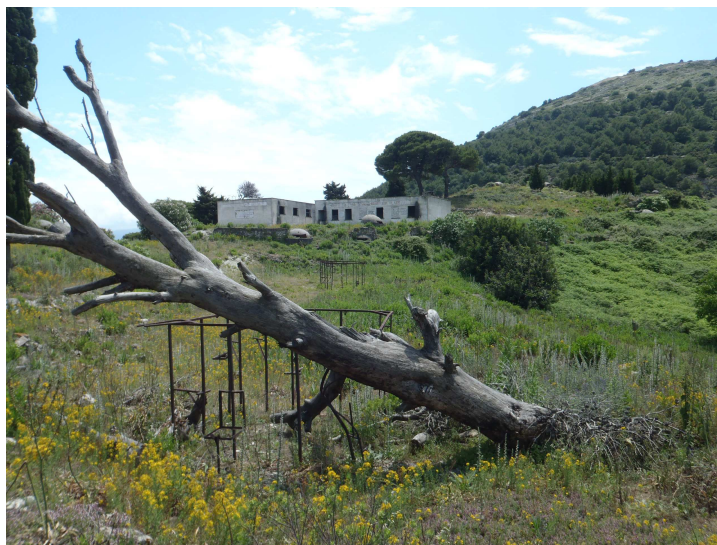
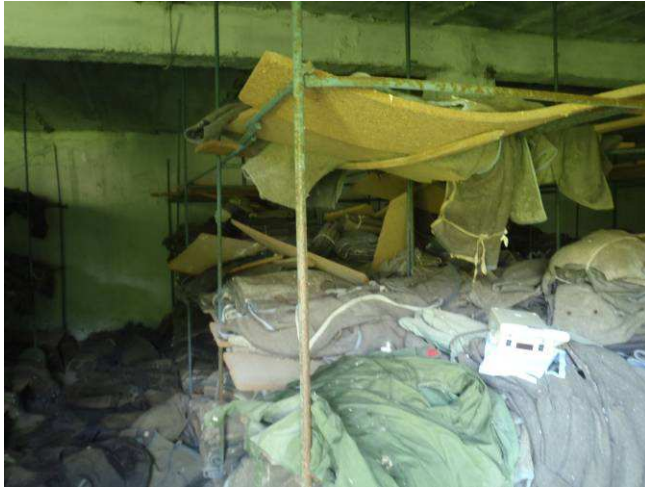
**Location 25:**

Ground floor bricks construction.

Metal : (2 metallic frames outside) 0.2 ton

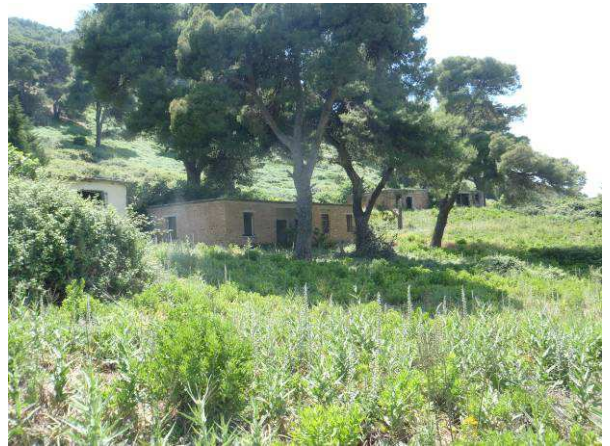
**Location 27:**  
 Ground floor bricks constructions in average condition.

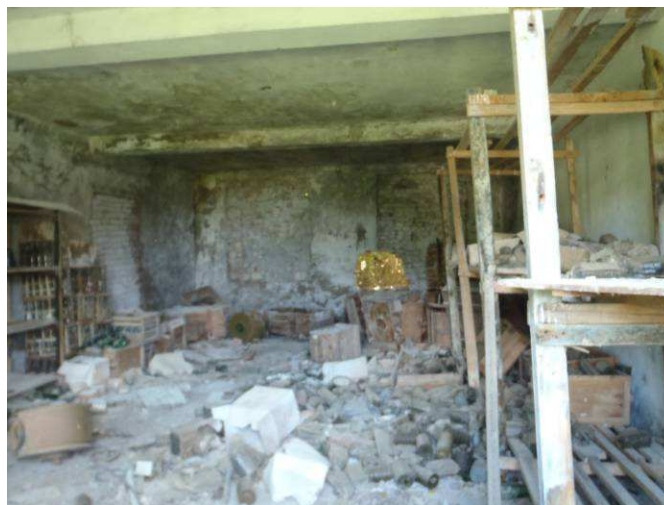
**Location 29:**  
 Ground floor bricks construction in average condition.  
 Metal : 0.2 ton  
 recent grenades (10 boxes).  
 Wood : 0.2 ton
