## EXPERTISE REPORT

December 2013

# Sazani island (Albania) : pollution and wastes field survey

Jean-Louis Lambeaux (13 Développement)

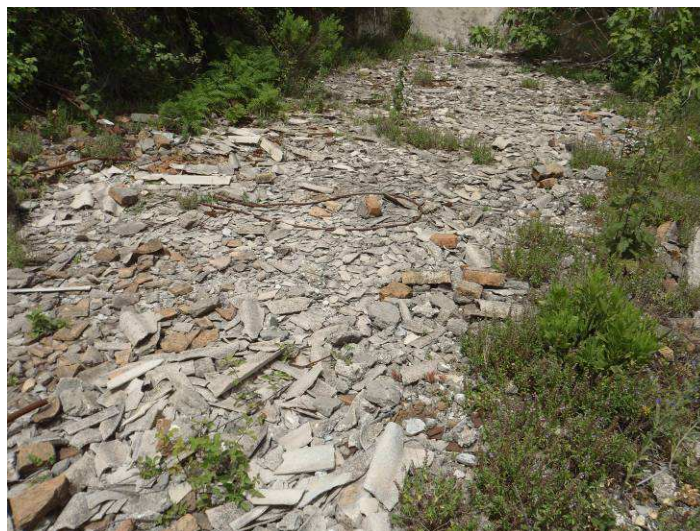
**Location 4:**

Large ground-floor masonry construction and concrete flat roof.

Metal : 1.5 tons

Wood : 0.1 tons

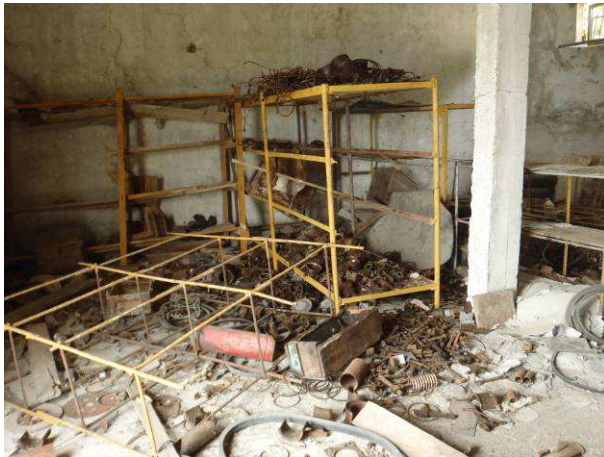
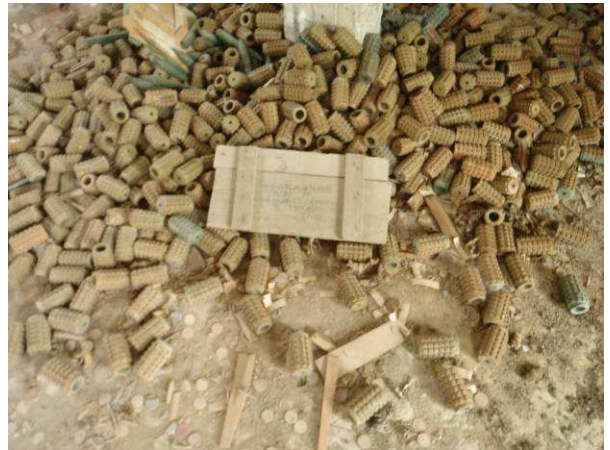
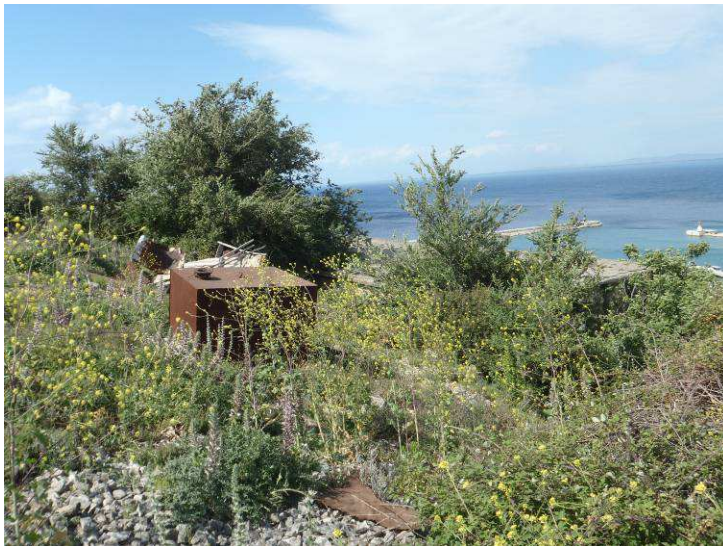
**Location 5:**

Group of four ground-floor masonry and concrete flat roof constructions.

Average condition.

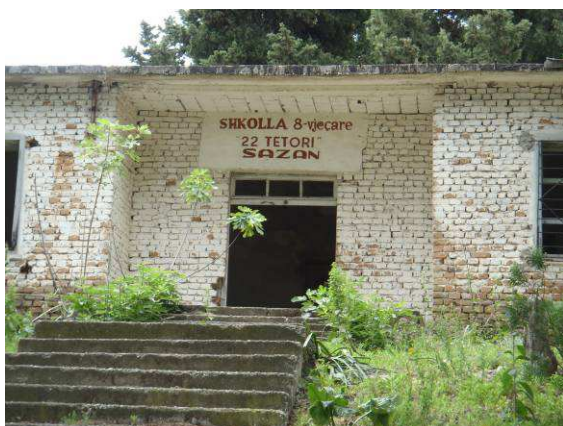
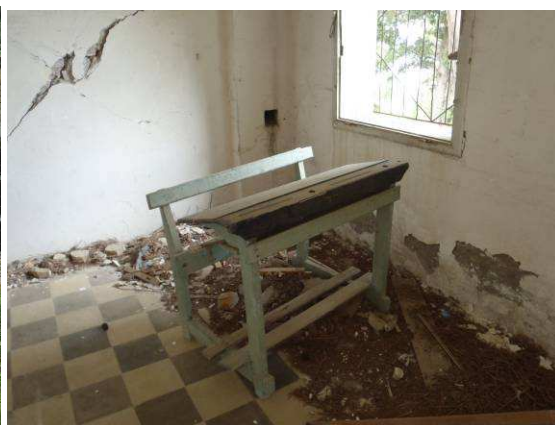
#### Location 2:

Housing : Two-floors masonry construction partly collapsed.

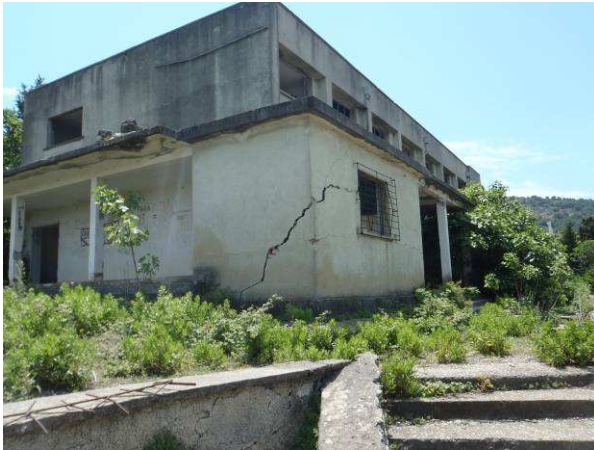
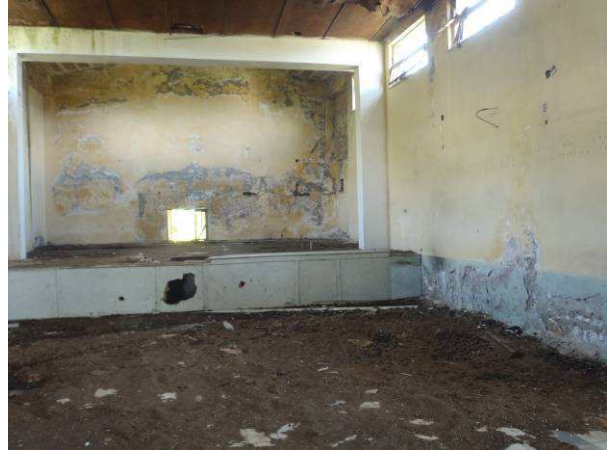
#### Location 16:

Small masonry construction.

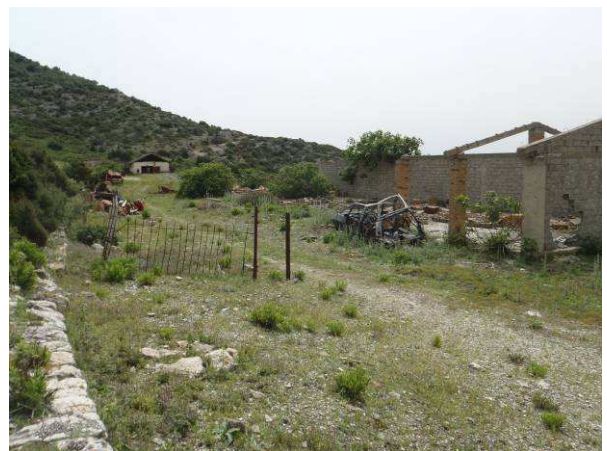
**Location 9:**  
Ground floor collapsed masonry construction.  
Metal : 0.5 ton (car wreck)

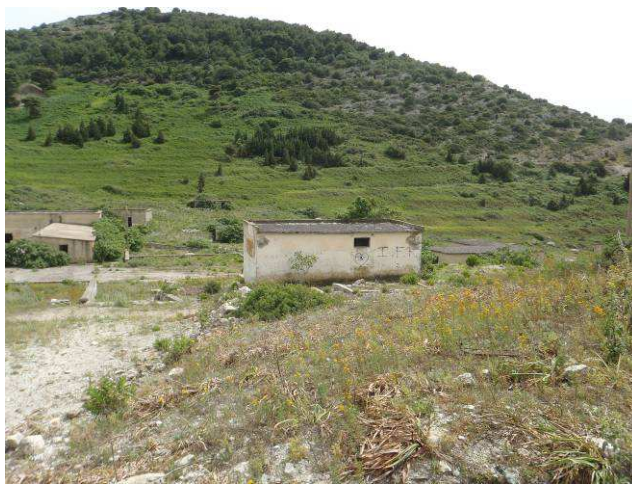
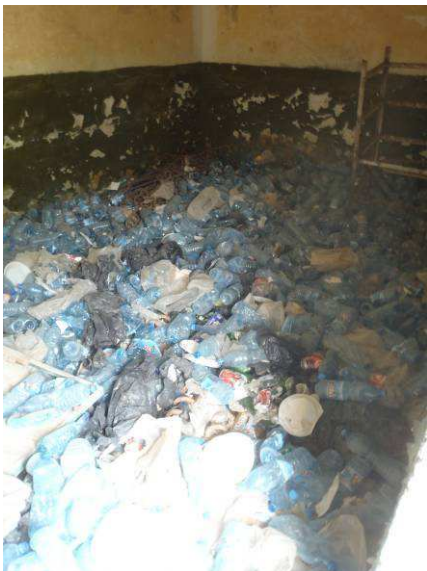
**Location 12:**

Two ground floor masonry and bricks construction.

Non-hazardous industrial waste (plastic bottles) : 0.1 ton

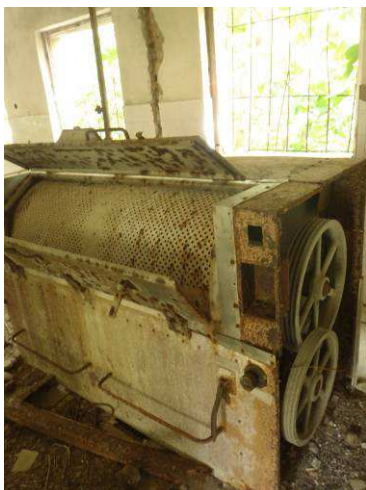
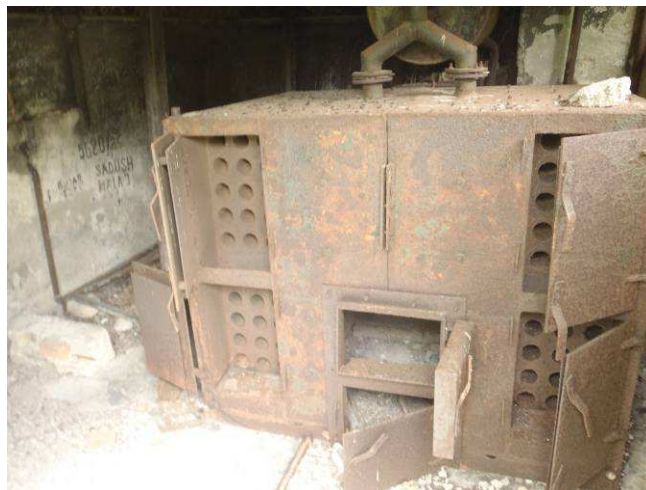
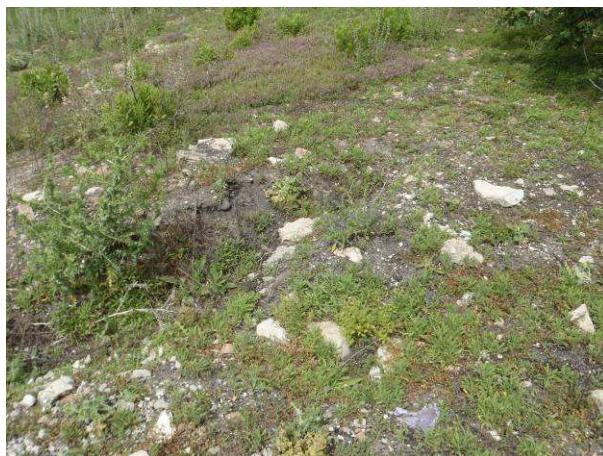
**Location 15:**

Ground floor bricks and concrete construction.

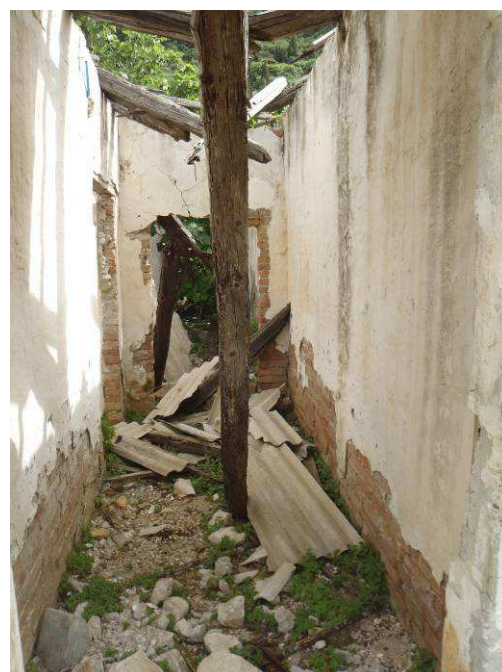
Ground floor masonry construction. Roof in asbestos plates collapsed (30 m<sup>2</sup>).

Metal : 0.1 ton (empty barrels)
